**Flood Control Project Maintenance
Levee Inspections**

Maintenance Issue Types Only, Levee Inspection Report By Mile - Fall 2019

Reclamation District No. 2094 Walthall

Waterway	Bank	Unit Miles	Inspection Start/End	Inspector
Unit No. 01 San Joaquin River	Right	2.78	11/21/2019 11/21/2019	Alberto De Leon

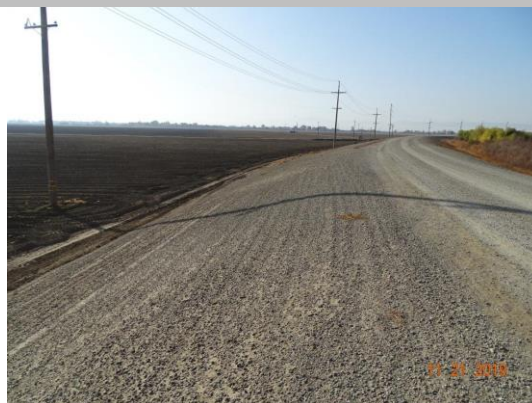
Photo 1 of 1 : FA_2019_RD2094_320_6_20191121_00017.jpg

LM Start	0.91	Rating **	A	Issue No.	6
LM End	0.91	Issue Type +	Ma	Location *	LS
Category	Earthen Levee			GPS Latitude/Longitude	
				Start	End
Item	Vegetation			37.764209°	37.764209°
				-121.293559°	-121.293559°
DWR ID	DWR_RD2094_01_f_2019_6				
Comment Code					
V1 : Control annual grass and weeds on the levee slopes and easements.					
Inspector Comment					
Annual vegetation is well maintained.

View of vegetation on landside slope. Fall 2019
